Overview

This report presents the results of a field reconnaissance conducted by EPA Region 10's Office of Environmental Cleanup in coordination with the Office of Environmental Assessment. The purpose of the study was to determine if asbestos was present at a site where a former quarry now abuts a residential development.

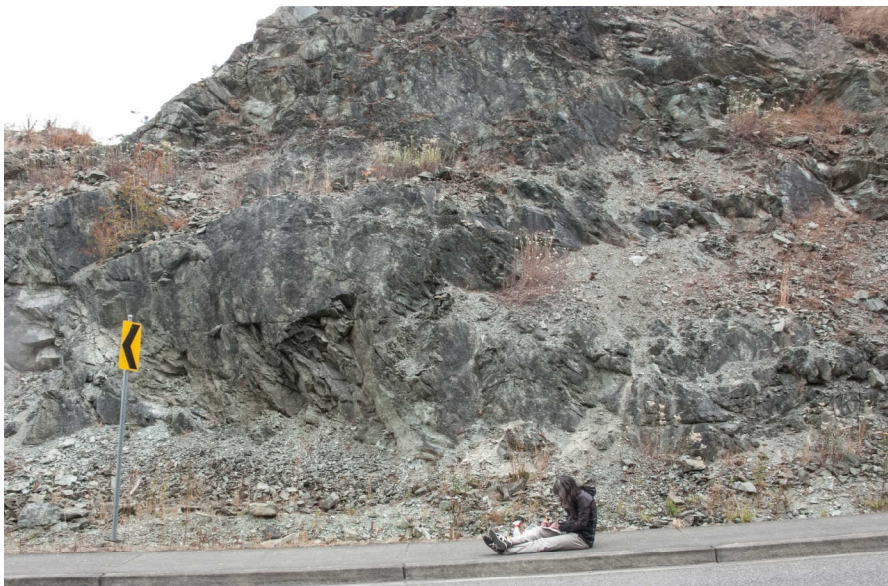
Starting at the northwest entry to the Burlington Hill development, the first samples were collected from a road cut on Hillcrest Drive, just as the road begins to climb uphill. We moved from downhill to uphill along the road cut and sampled three separate sample sites (see Table 1), but these are considered one sample location.

The rock throughout the road cut is a highly fractured green schist. Some zones are lighter than others and have a talc consistency.

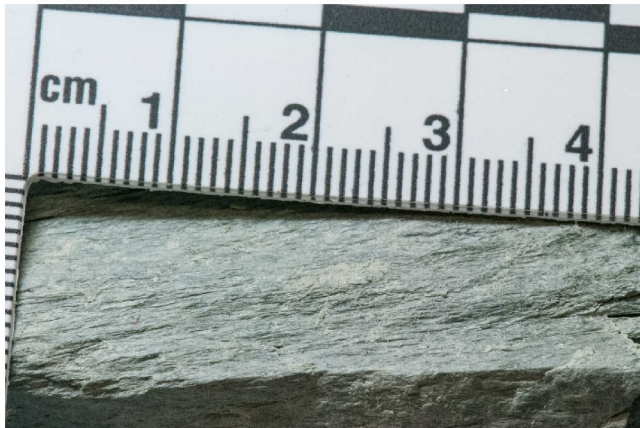
The image above is from the farthest downhill sample for MEL (12090101). Some minor quartz veins are apparent in the hand sample, but nothing obviously fibrous. Material is weathered, fine-grained, light green, and has a talc or soapstone consistency. The texture of the rock is slaty and with no apparent fibers, but there are some small needle-shaped crystals.

Field Notes from the site visit are included as **Appendix A**. Table 2 summarizes the PLM results from the commercial laboratory and Table 3 presents a summary of PLM results from MEL. Note that asbestos was identified only at Location 1. The type of asbestos identified was actinolite asbestos, which is consistent with what was reported by USGS (Van Gosen 2010). No other types of asbestos were identified at the site. MEL reported much higher concentrations (i.e., 15-20%) compared to what the commercial laboratory reported (i.e., 0.5 – 0.75%). This is likely because the MEL analyst received whole specimens and likely picked through these looking for suspect asbestos when making his preparations, whereas the commercial laboratory milled the sample as received and processed it without any bias.

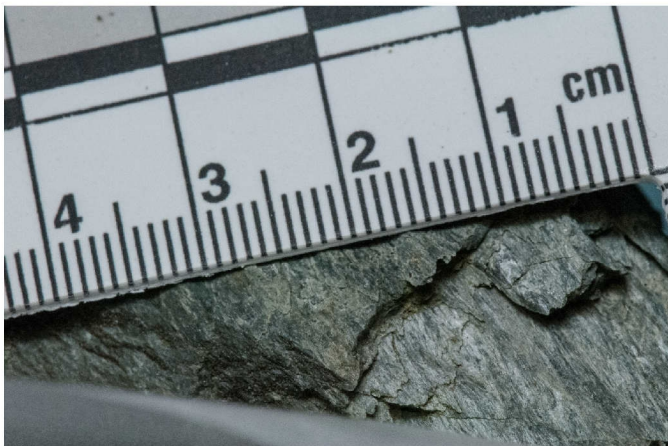
The mid-hill sample from same road cut (i.e., second sample for MEL, 12090103) is slightly up the hill from the previous sample. The rock has a green and very platy texture overall. This sample is also not obviously fibrous, but some fragments are very needle-like. The finer, more weathered material was sampled for PLM analysis (12090104).

The image above is the platy rock collected as MEL 12090103.

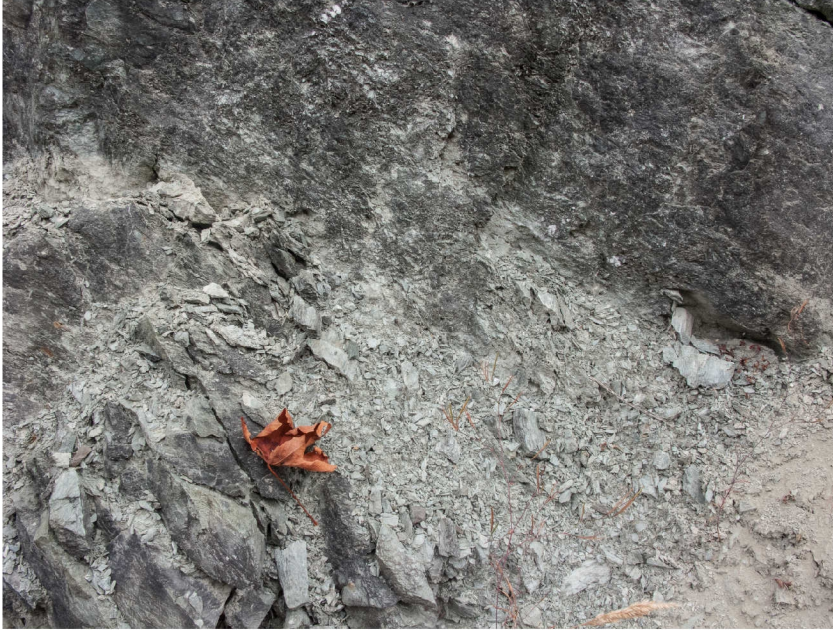
The most uphill sample from the same road cut is for PLM (12090105). This is from some more weathered material, pale green, with a shaly texture and fractures that contain what seems to be a fibrous material, with needle-like structure. This sample was from the uphill edge of the outcrop, just below the cement block retaining wall.

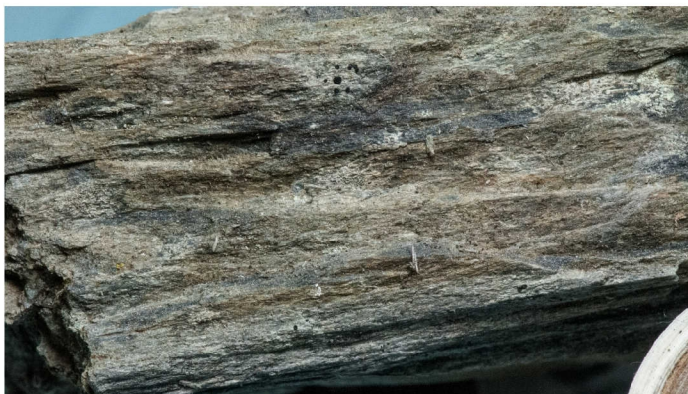
These samples are from a residence on Tinas Coma Drive. The first is from an outcrop to the left of the upper garage door (south of driveway). The rocks here are striated, weathered, and have a sort of "woody" texture from a distance (sample 12090106).

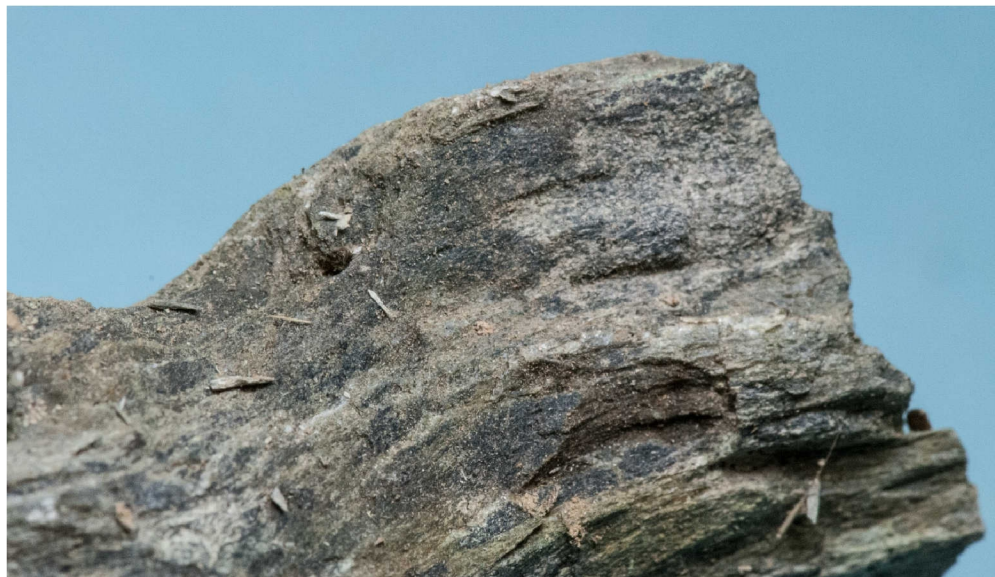
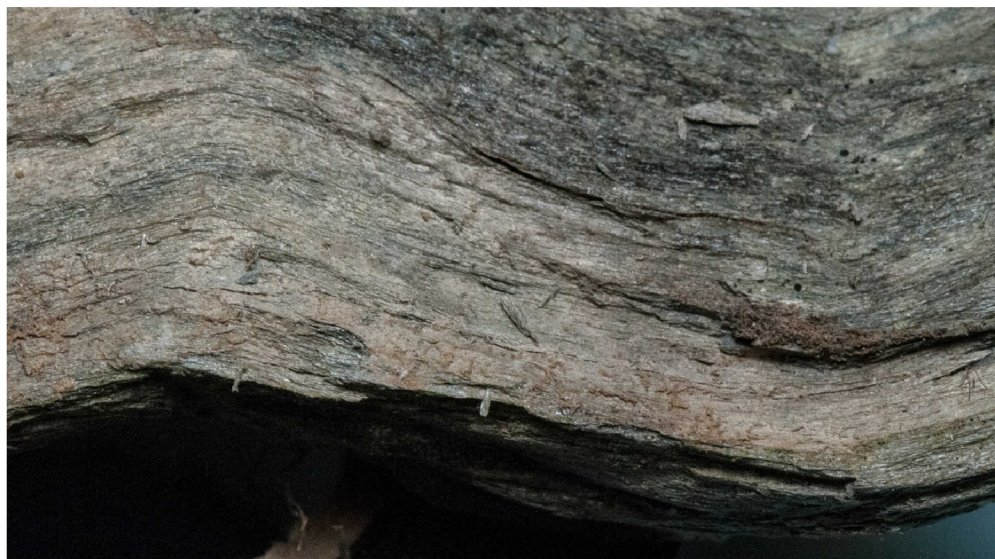
In the hand sample, the texture is very platy and contains needle-like crystals.

The PLM sample collected has some organic matter (12090107). This sample does not show obvious fibers, but has a needle-like texture locally, although most of the rock is platy.

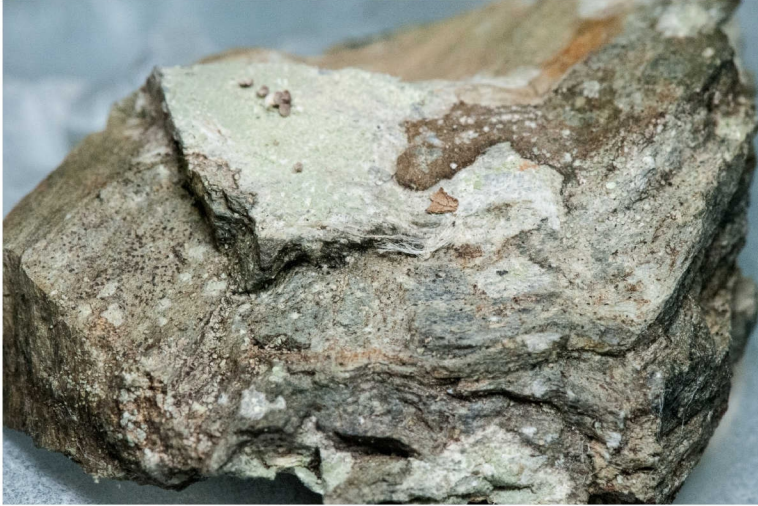
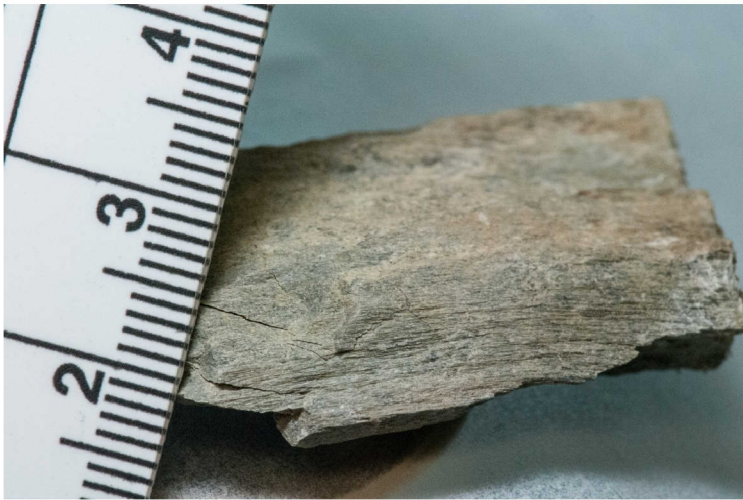
The next sample was collected adjacent to the garage, on the left side (west) of the driveway. The light green material was observed and one surface looks very fibrous.

The sample (12090108) collected was farther along driveway, at the garage corner. A fractured surface shows the fibrous material visible with a hand lens.

PLM sample collected at 12:02 PM is along a hillslope outcrop adjacent to the family room window of the residence (12090109). This is a darker rock with a slaty texture; some of the thin veinlets on surfaces look fibrous.

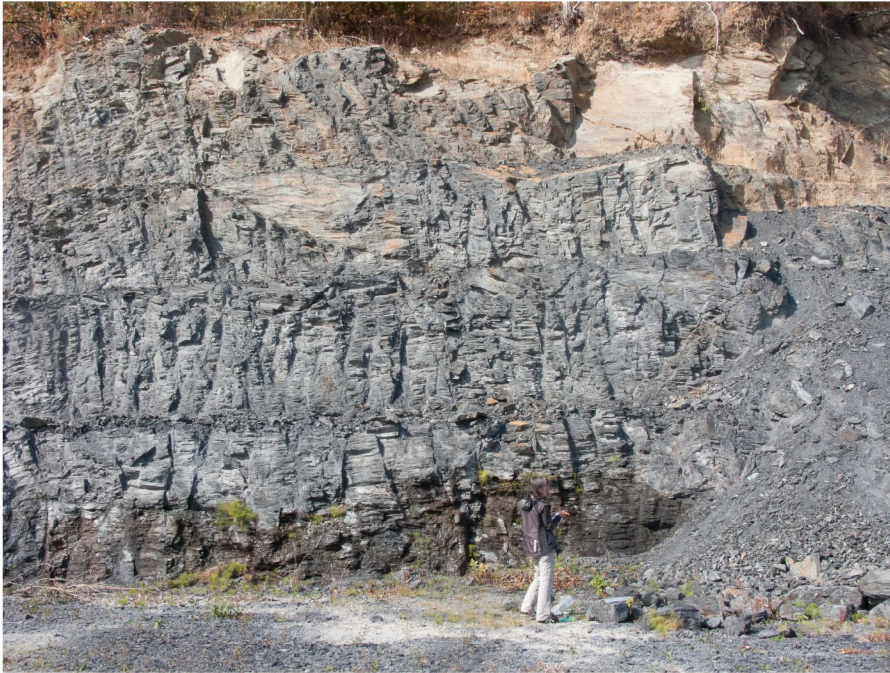
This is reportedly the old quarry site, and contains remnants from some site preparation for planned condos that were never built. The rock along the back wall is dark gray, almost black, has a slaty texture, but is competent enough to hold a nearly vertical slope.

The right end of the wall (north) is our first sample location (12090110). There is no obvious veining or fibers or even needles, and not even much of the gray-green altered rock at this location, although both the north and south ends have a little more weathering or alteration. There is no evidence of the talc that was reportedly mined here. A few quartz veinlets are present. The hand sample is dark gray, very foliated, with no visible fibers.

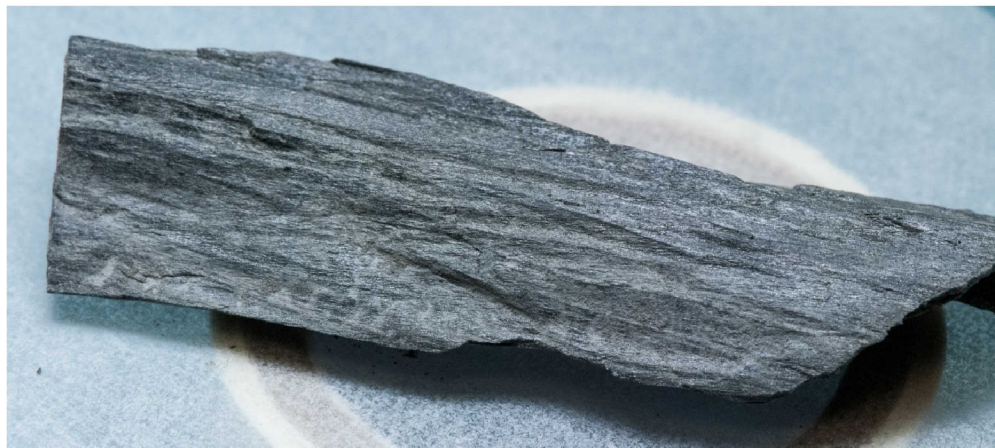
A sample for PLM analysis (above, 12090111) was collected from a more weathered zone at the north end of the quarry wall.

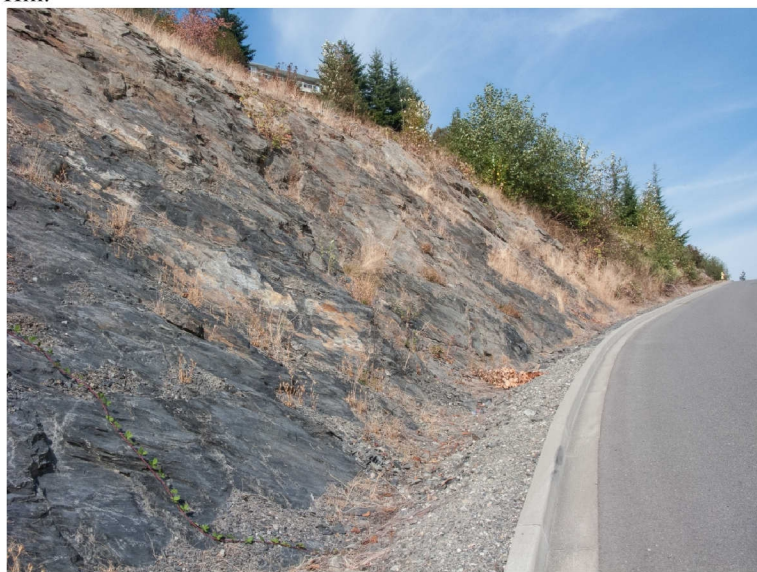
| The final location was the road cut at the neighborhood entry on southeast side of Burlington Hill.

Here the rocks look similar to those seen at Location 3. The light gray-green color or the talc consistency layers observed at Location 1 were not observed here. The rock is more competent and also contains some of the quartz veinlets. At the end of cut (uphill), some of the altered greenish rock with needle-like structures along fractures was observed and sampled (12090113, see below). Note that this sample was not under custody the entire time prior to analysis. The rock is dark gray and shaley, and not visibly fibrous, but the thin green fractured surface could be different. No fibers were visible with hand lens, however.

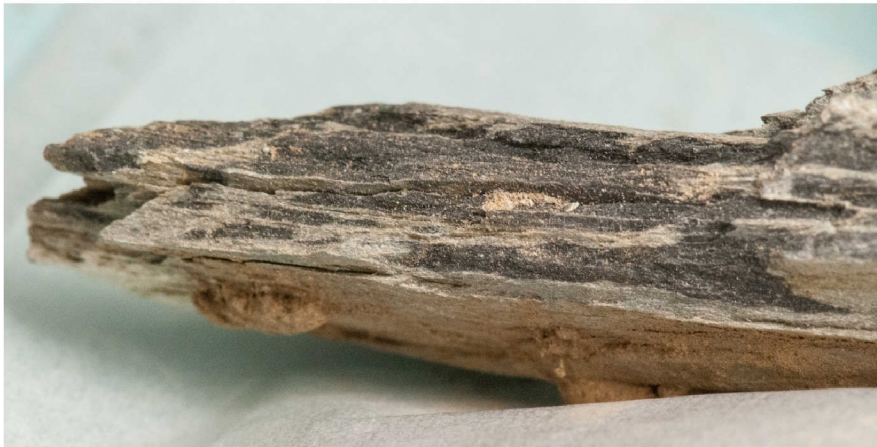
Another sample (12090114) was collected from north (uphill) end of the road cut. A final sample was collected at south end of cut (12090115). Nothing fibrous was observed in the hand sample.
